MLB/SERV (MOTOR LIFE BOATS/SURFACE
EFFECT RESCUE VEHICLES) OPERATION
STUDY

MLB/SERV OPERATION STUDY

U.S. Coast Guard Station

**MLB/SERV Unit 3960-01
1 January 1973**

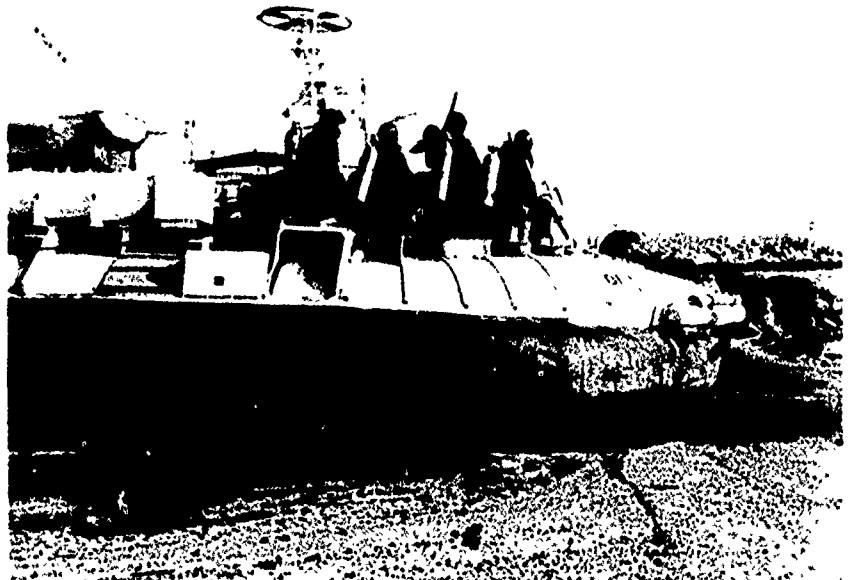
SERV underway enroute simulated crash site

Simulated crash site located at the shallow water approaches to Oakland International Airport.

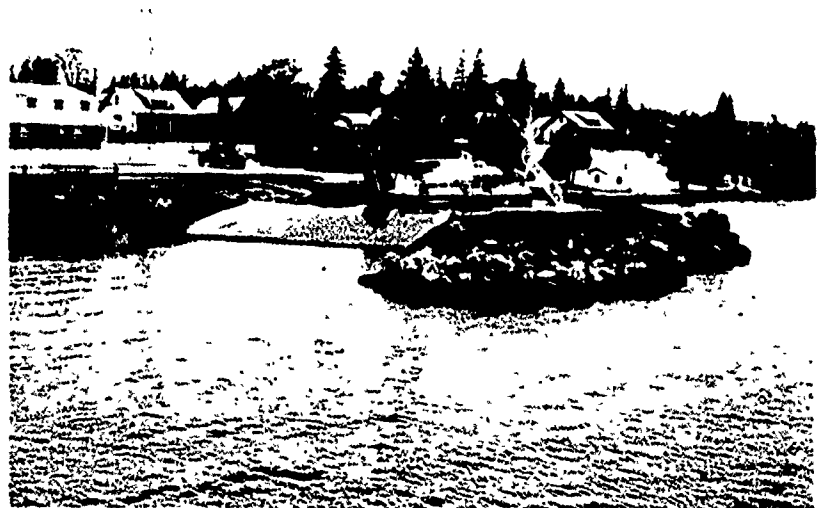
SERV operating ramp and
apron at Station St Ignace
(Northern Great Lakes)
summer.

Station St Ignace facility
during winter (obvious
requirement for sheltered
maintenance area).

BOAT/SERV STATION FACILITIES: It has been shown in all of the CG SERV operations to date, that probably all of the existing Coast Guard small boat stations can be easily modified to accept SERV operations. Not only has this been proven at Fort Point Coast Guard Station (Figure E-1), but also at Saint Ignace Coast Guard Station in the Ninth District, and Milford Haven Station in the Fifth District (Figure E-2). Although the boat maintenance facilities utilized at both the fifth and ninth district operational sites were adequate for routine SERV maintenance, they were not adequate enough to conduct some of the more demanding SERV hull maintenance that was frequently required, especially with the SK-5 model ACV. One very notable deficiency was the inability to lift the SERV for routine bottom inspection. In order to accomplish this, commercial cranes had to be utilized. Another significant problem area, with regard to SERV maintenance support at the fifth and ninth district sites, was the lack of a sheltered SERV maintenance facility. This also hindered good maintenance practices.
